Subject: Department of Natural Resources Washington Geological Survey,  
School Seismic Safety Assessment Project, Contract No. AE 410 -  
Seismic Evaluation for **Camas School District**

**Table 1-3. Identified Structural Seismic Deficiencies for Camas Lacamas Heights Elementary School 100 Pod**

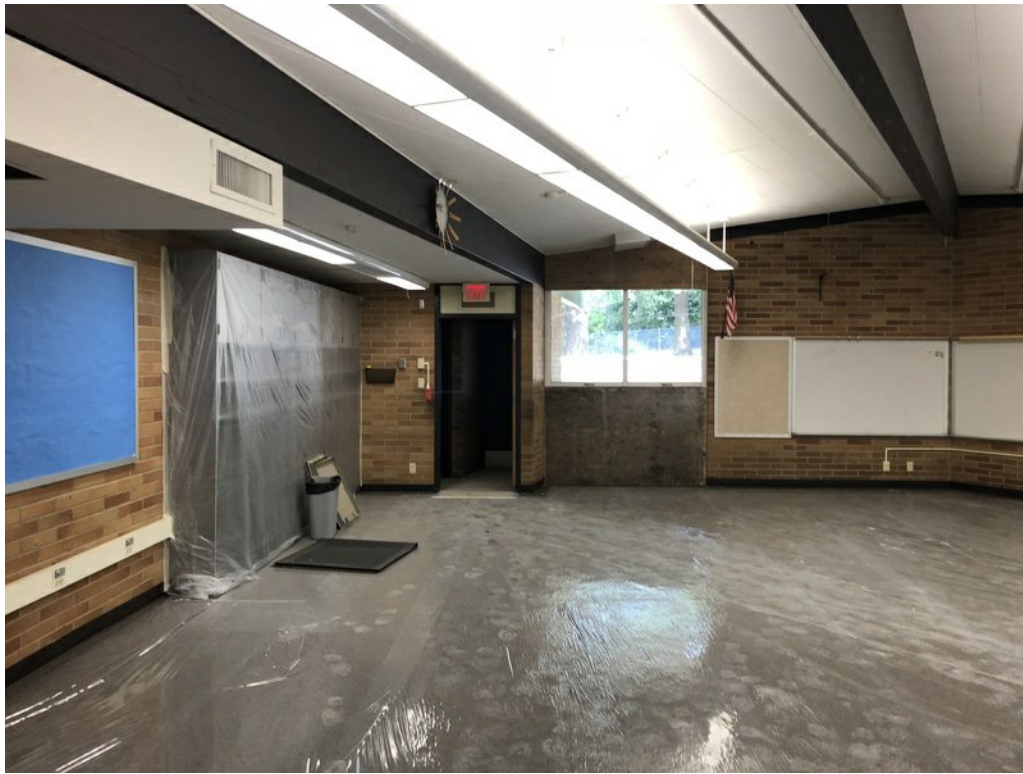
**Figure 1-4. Classroom 108/109 with Moveable Partition**

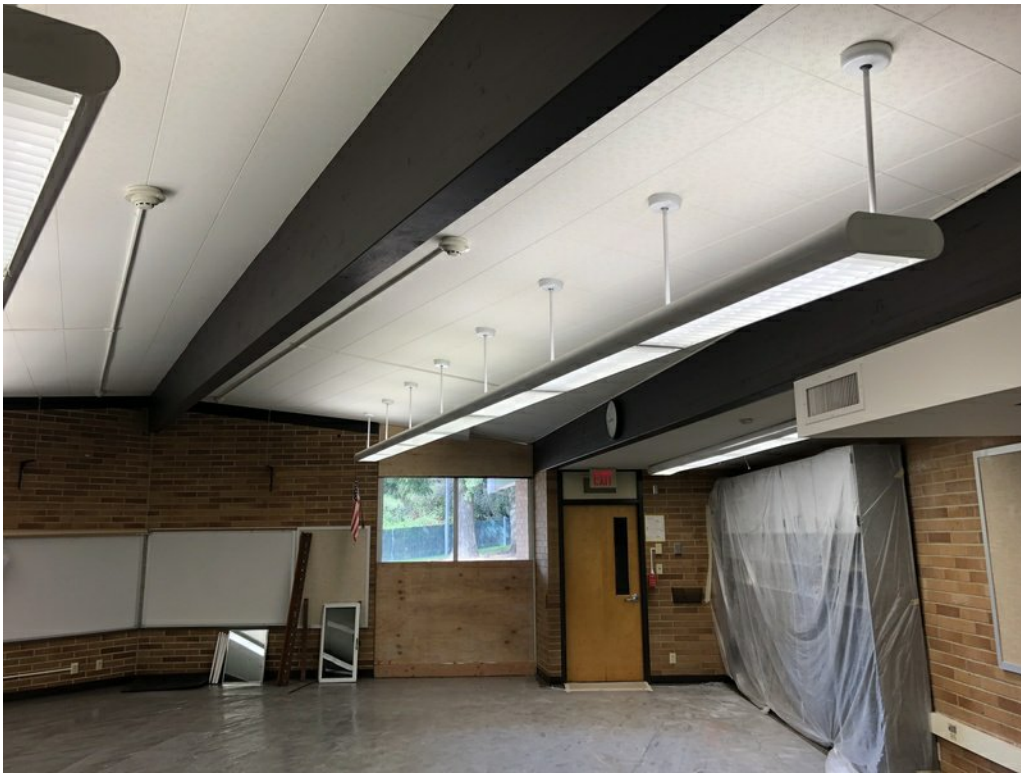
Deficiency	Description
P-1 Unreinforced Masonry. HR-LMH; LS-LMH; PR-LMH.	Inadequate bracing for URM partitions. URM partitions should be braced at a maximum of six feet.
CF-2 Tall Narrow Contents. HR-not required; LS-H; PR-MH.	Anchorage is required for tall narrow contents more than six feet high to provide overturning restraint.

**Figure 1-6. Classroom 108 with Unreinforced Exterior Masonry Walls**

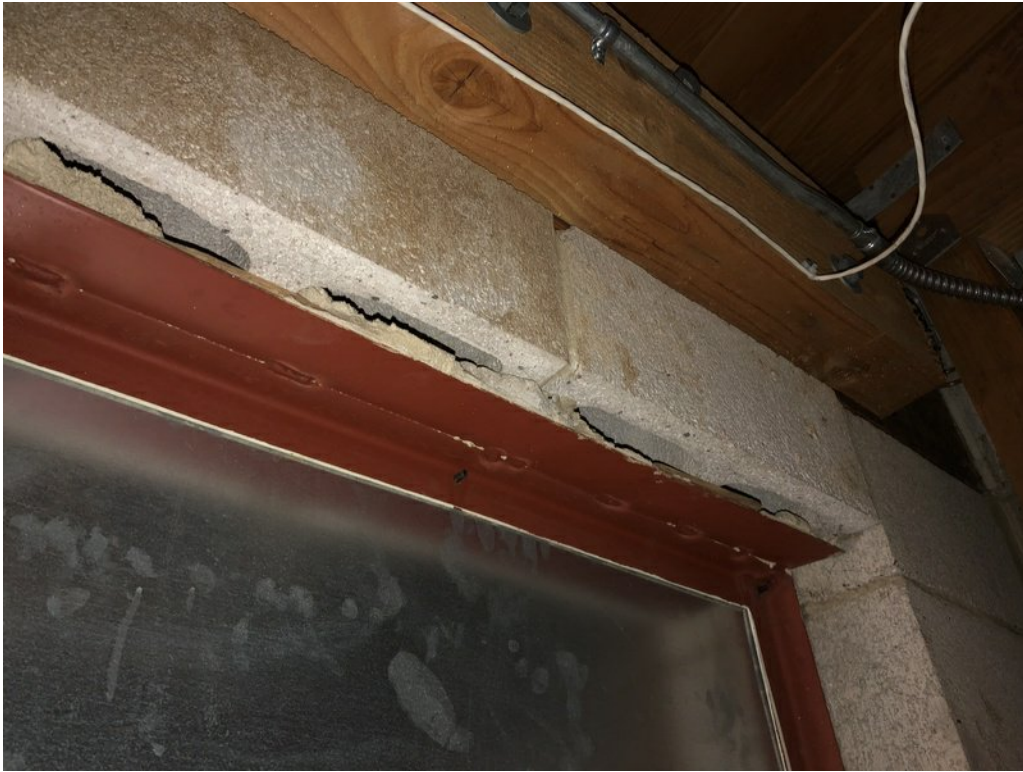
**Figure 1-9. Hollow CMU Lintel**

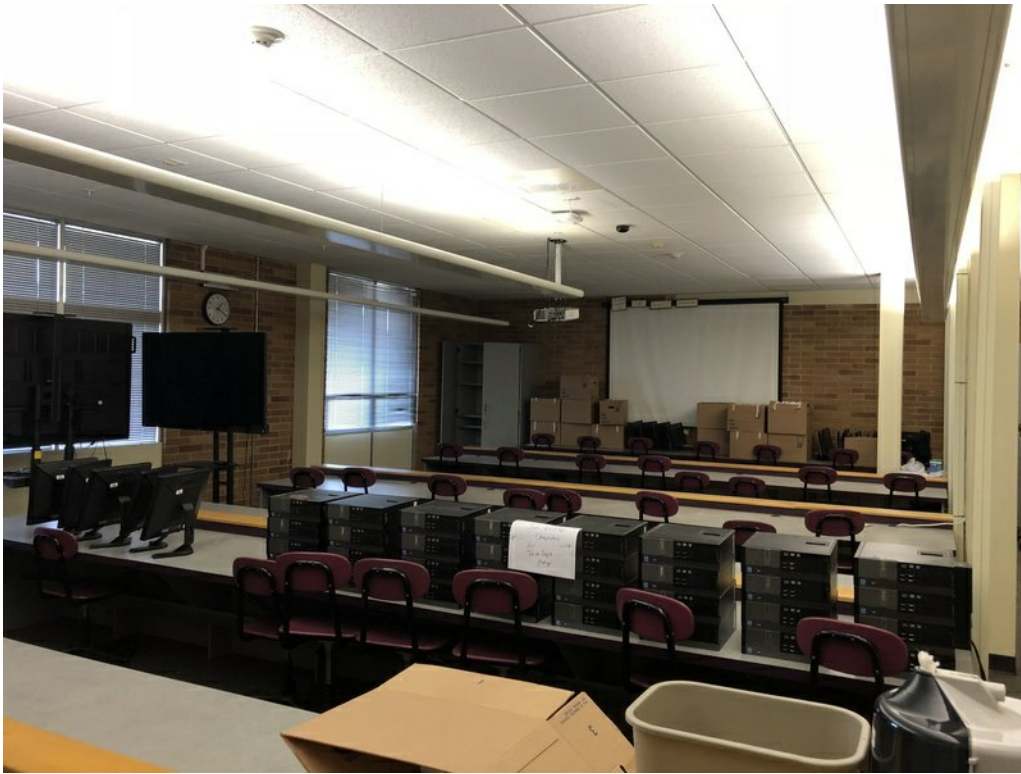
**Figure 1-7. Computer Lab with Unbraced Tall Narrow Contents**

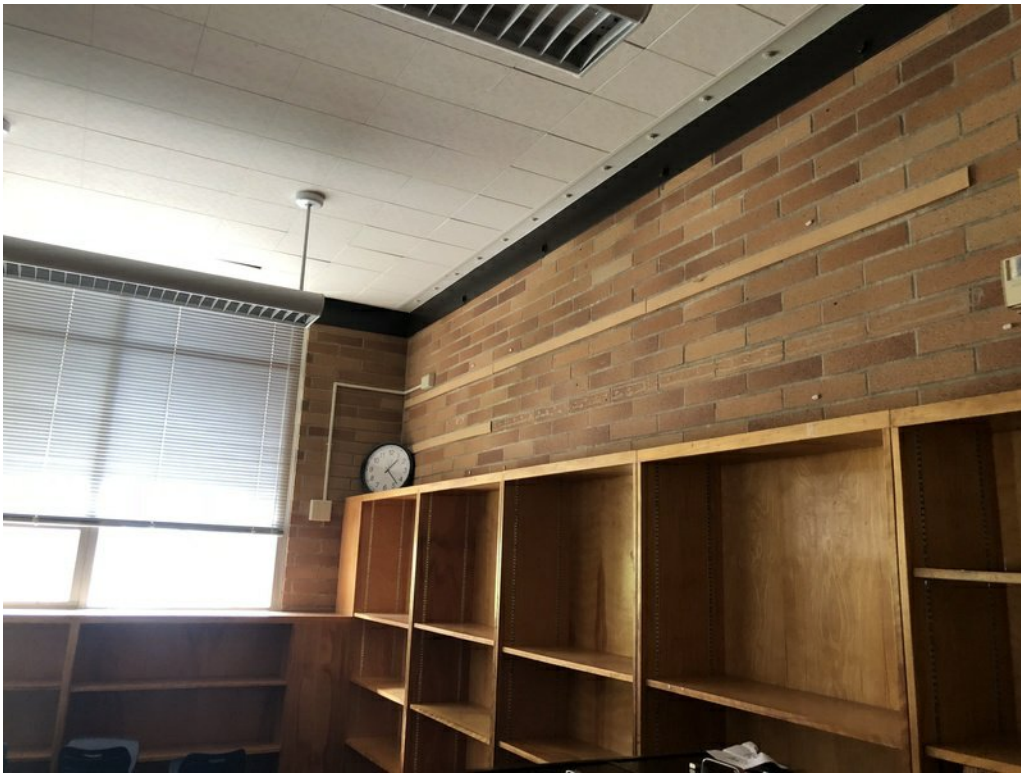
**Figure 1-9. Connection of Roof Diaphragm to Masonry Wall (1996 Remodel)**

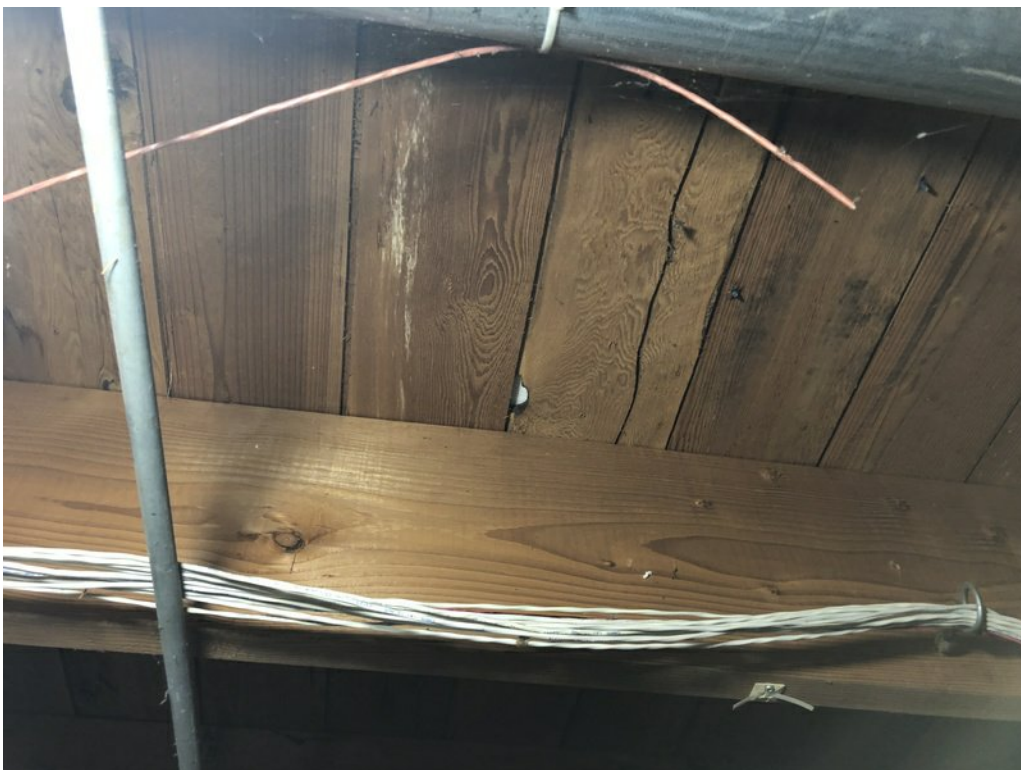
**Figure 1-6. Straight Sheathing Diaphragm Crack**

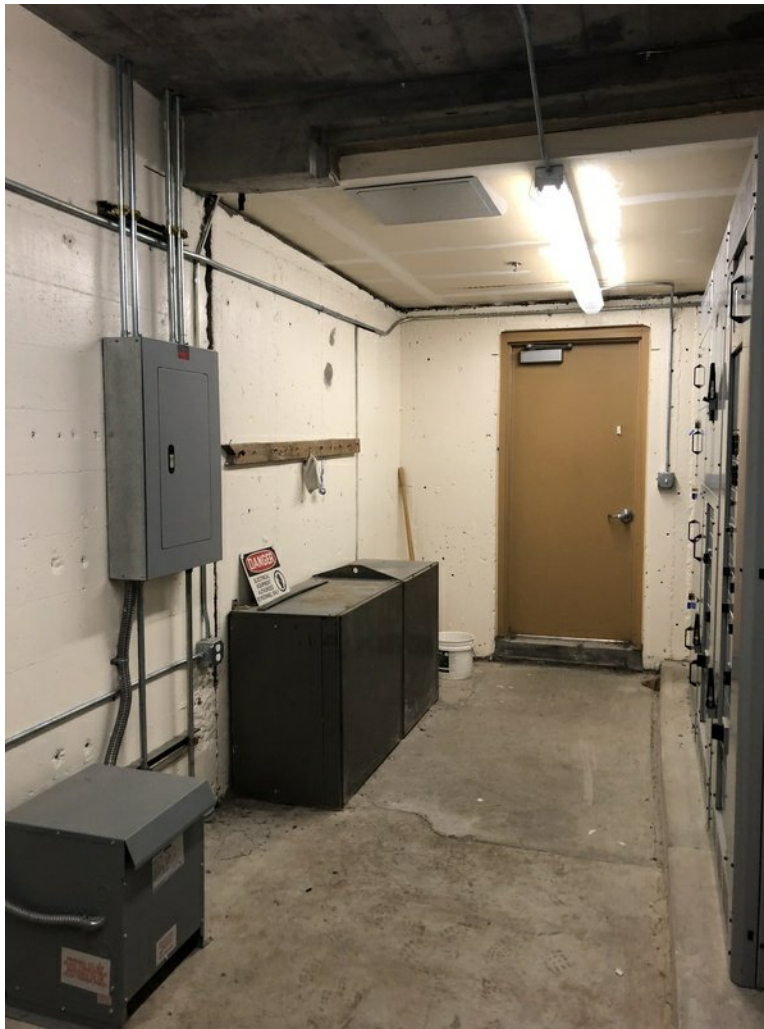
Figure 1-7. Cracking in Masonry Wall

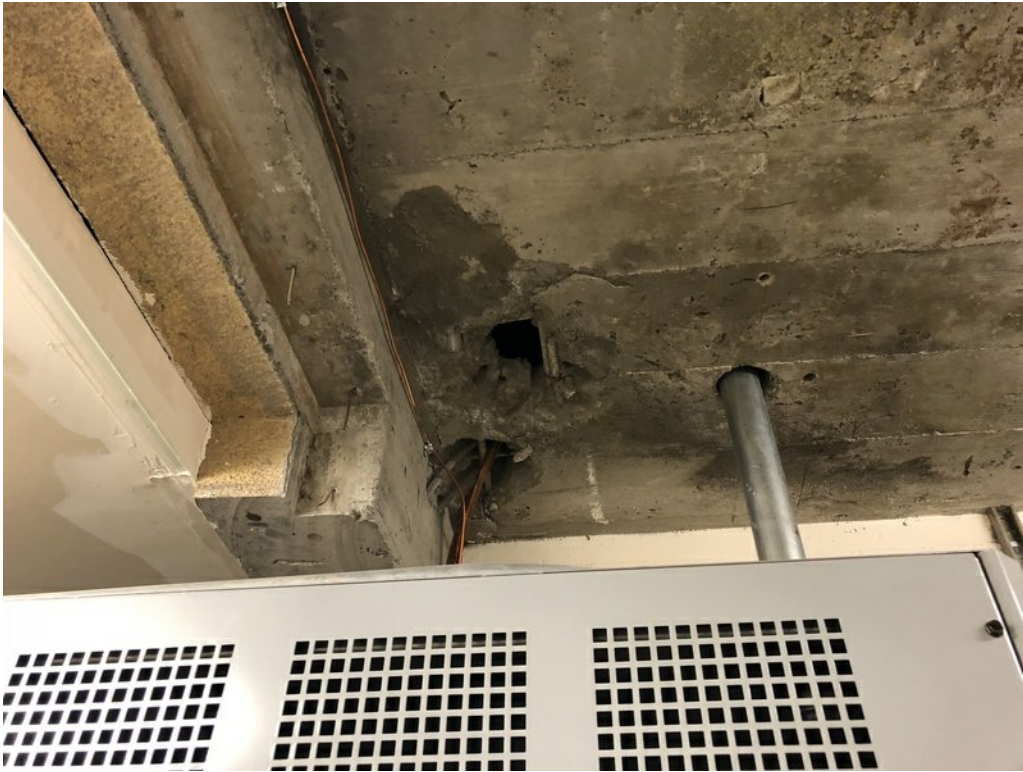
Figure 1-8. Concrete Spalling

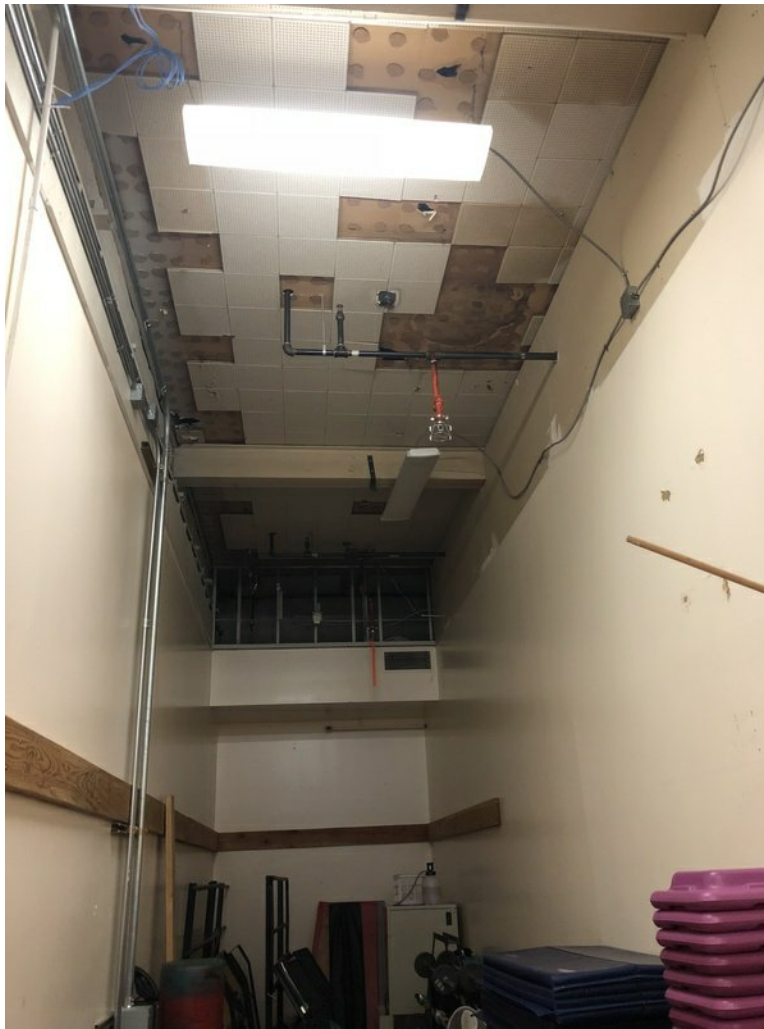
**Figure 1-9. Water Damage in Ceiling**

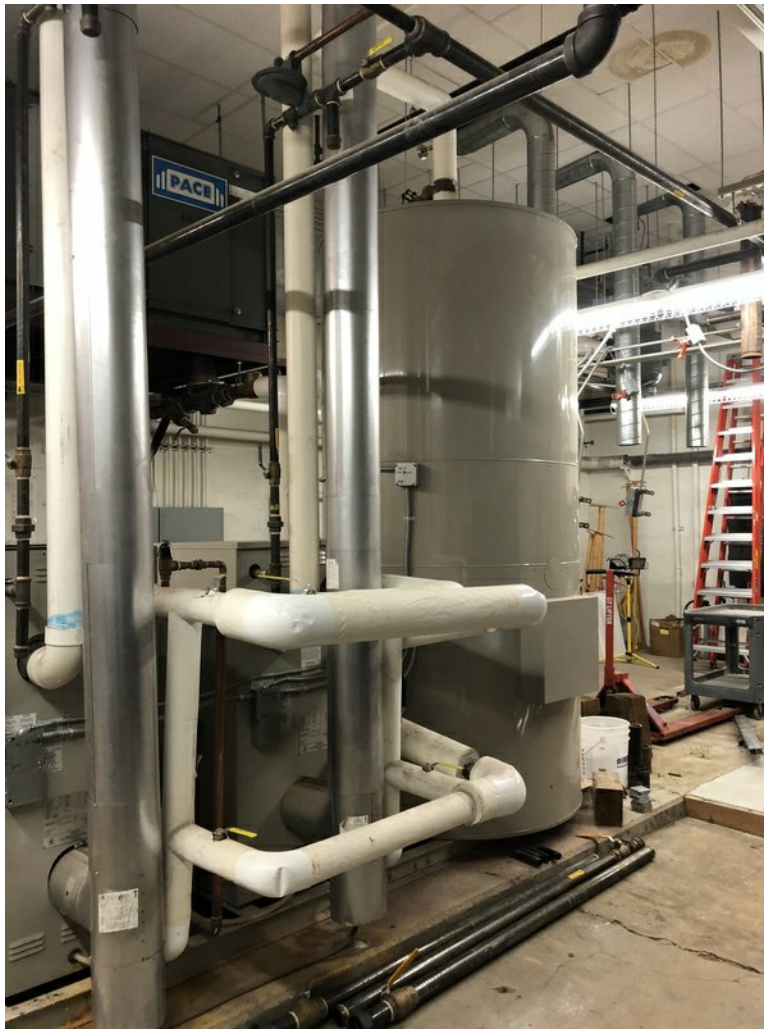
**Figure 1-10. Concrete Floor Cracking**

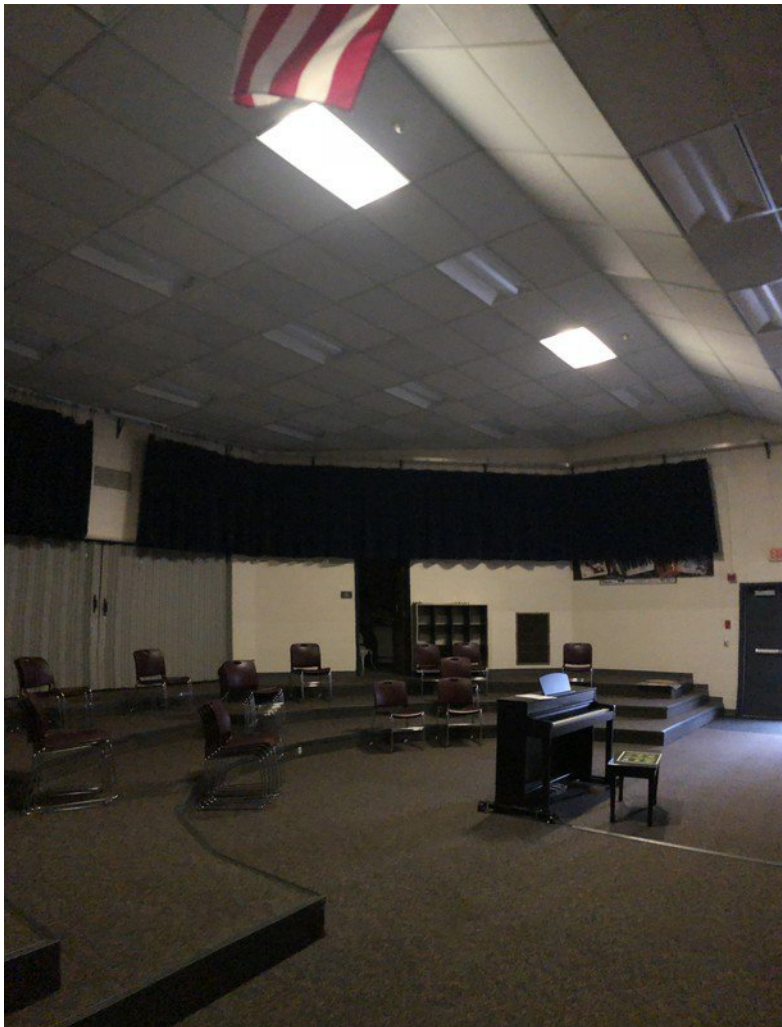
**Figure 1-4. Choir Room with Unknown Light Fixture Bracing**

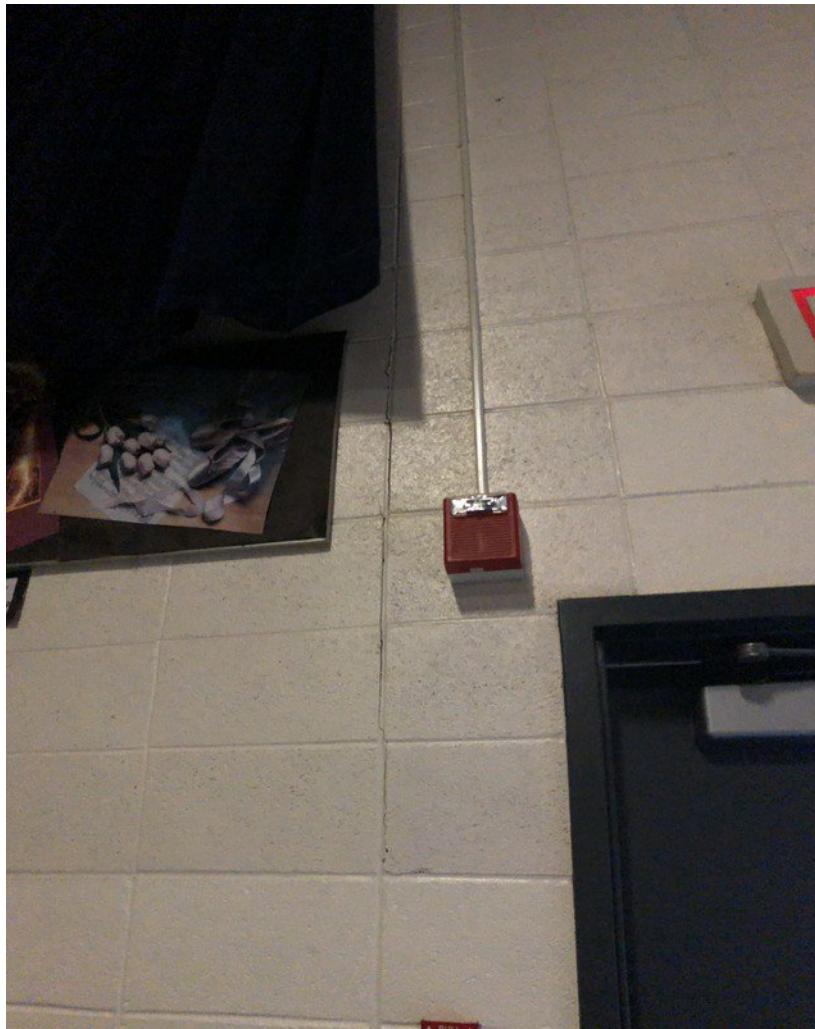
**Figure 1-9. Mortar Cracks, Typical**

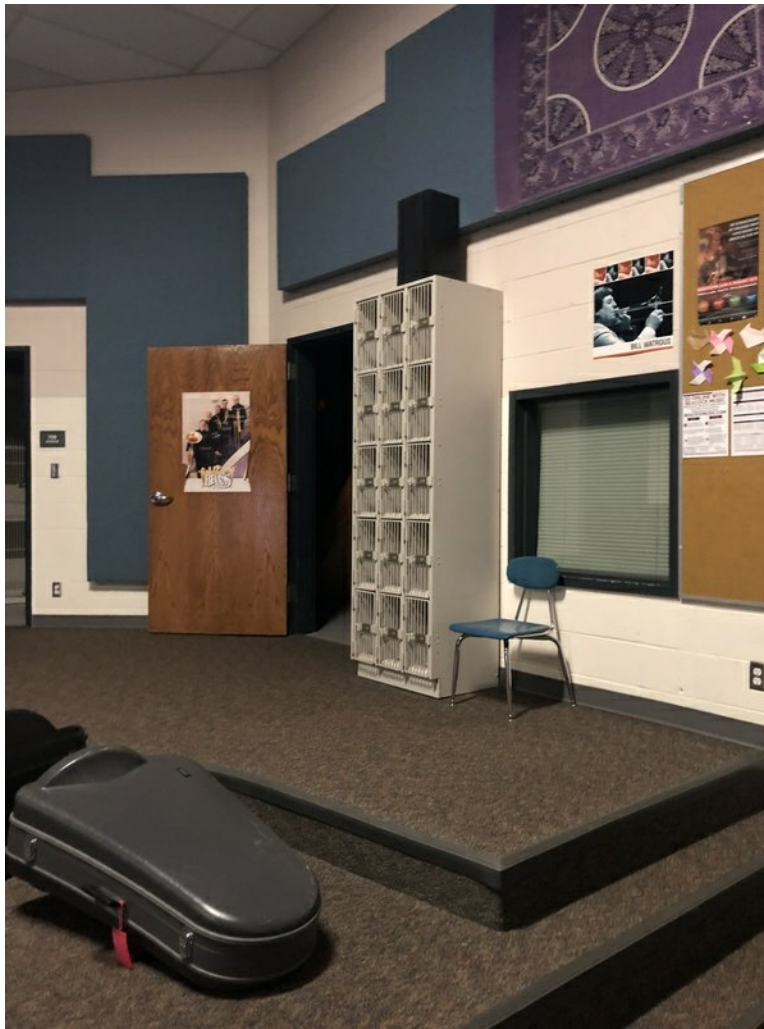
Figure 1-10. Tall Nonstructural Components Unbraced, Typical Throughout

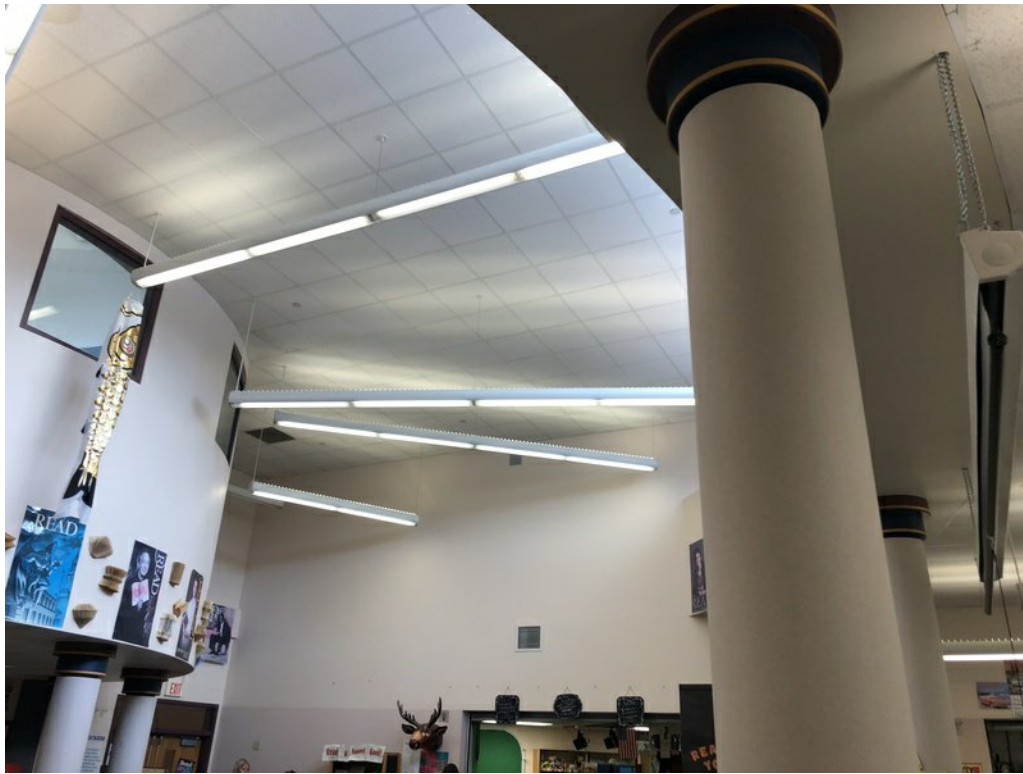
Figure 1-6. Commons Roof Framing, Steel Bracing, and Unbraced Ducts at Windows
